**RADIOLOGICAL CHARACTERIZATION REPORT FOR
FUSRAP PROPERTIES IN THE ST. LOUIS, MISSOURI, AREA**

VOLUME I

MARCH 1990

**K. C. Noey
C. M. Sekula
Bechtel National, Inc.
Oak Ridge, Tennessee**

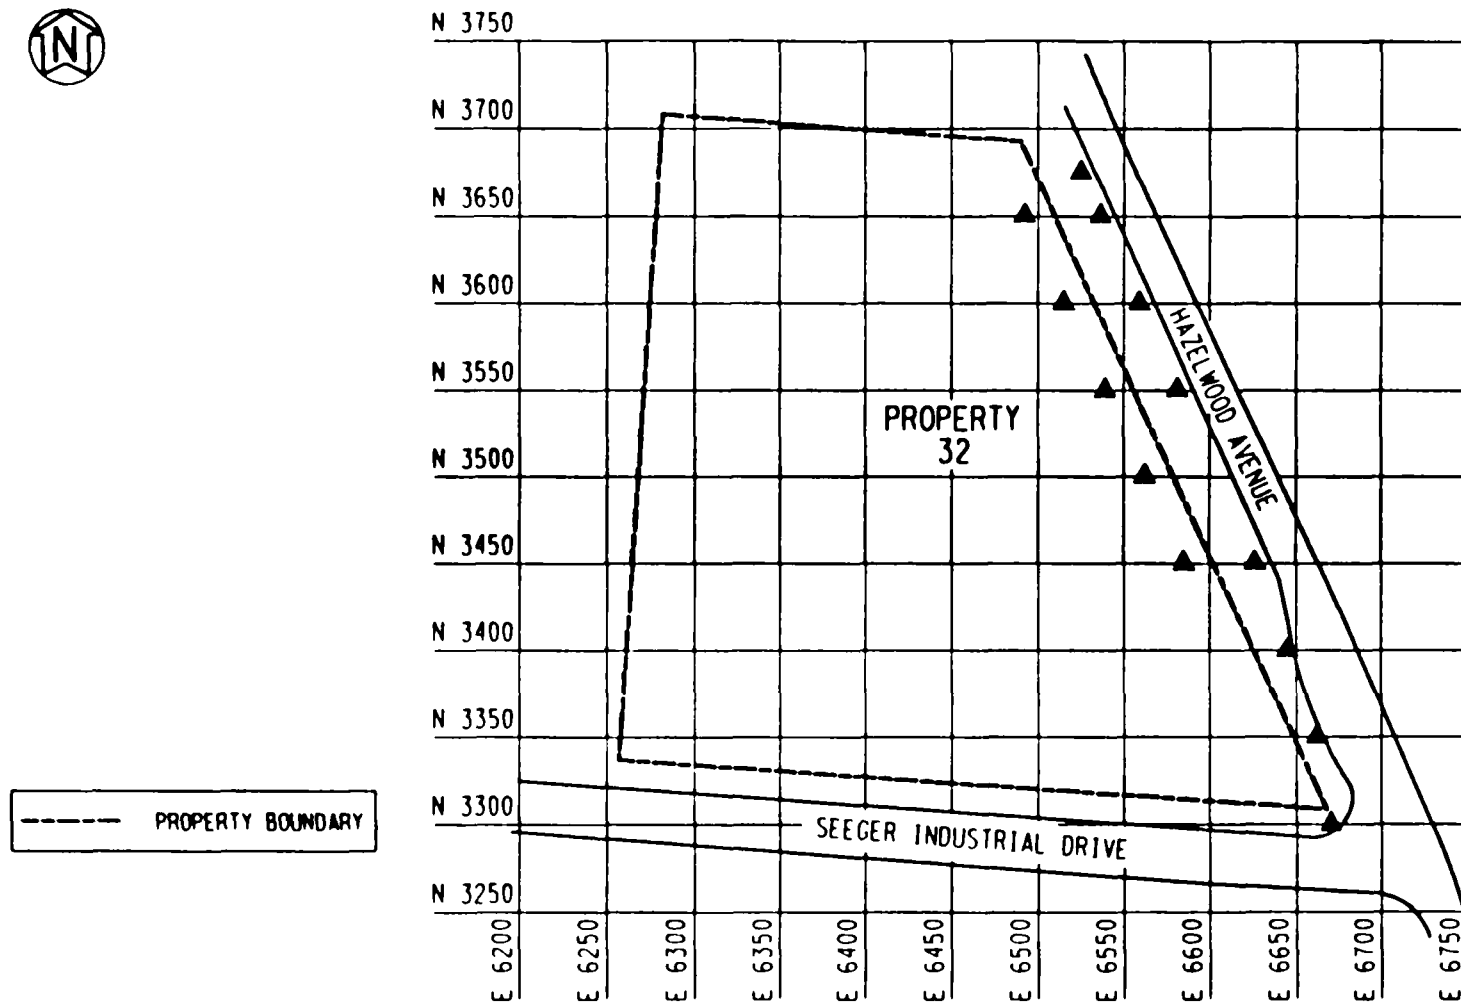
FIGURE 5-65 SOIL SAMPLING LOCATIONS FOR RADIOLOGICAL CHARACTERIZATION OF HAUL ROADS VICINITY PROPERTY 32

Property 32 is located on the corner at the intersection of Hazelwood Avenue and Seeger Industrial Drive. Locations from which soil samples were collected and analyzed are shown in Figure 5-65. Analytical results for soil (Table 5-41) revealed six sampling locations with elevated concentrations of thorium-230, which ranged from less than 0.3 to 540 pCi/g. Areas and depths of radioactive contamination at Property 32 are shown in Figure 5-66. Before remedial action begins, additional soil samples will be collected and analyzed to better define the boundaries of contamination. The areas of contamination shown in Figure 5-66 depict a conservative estimate of contamination boundaries.

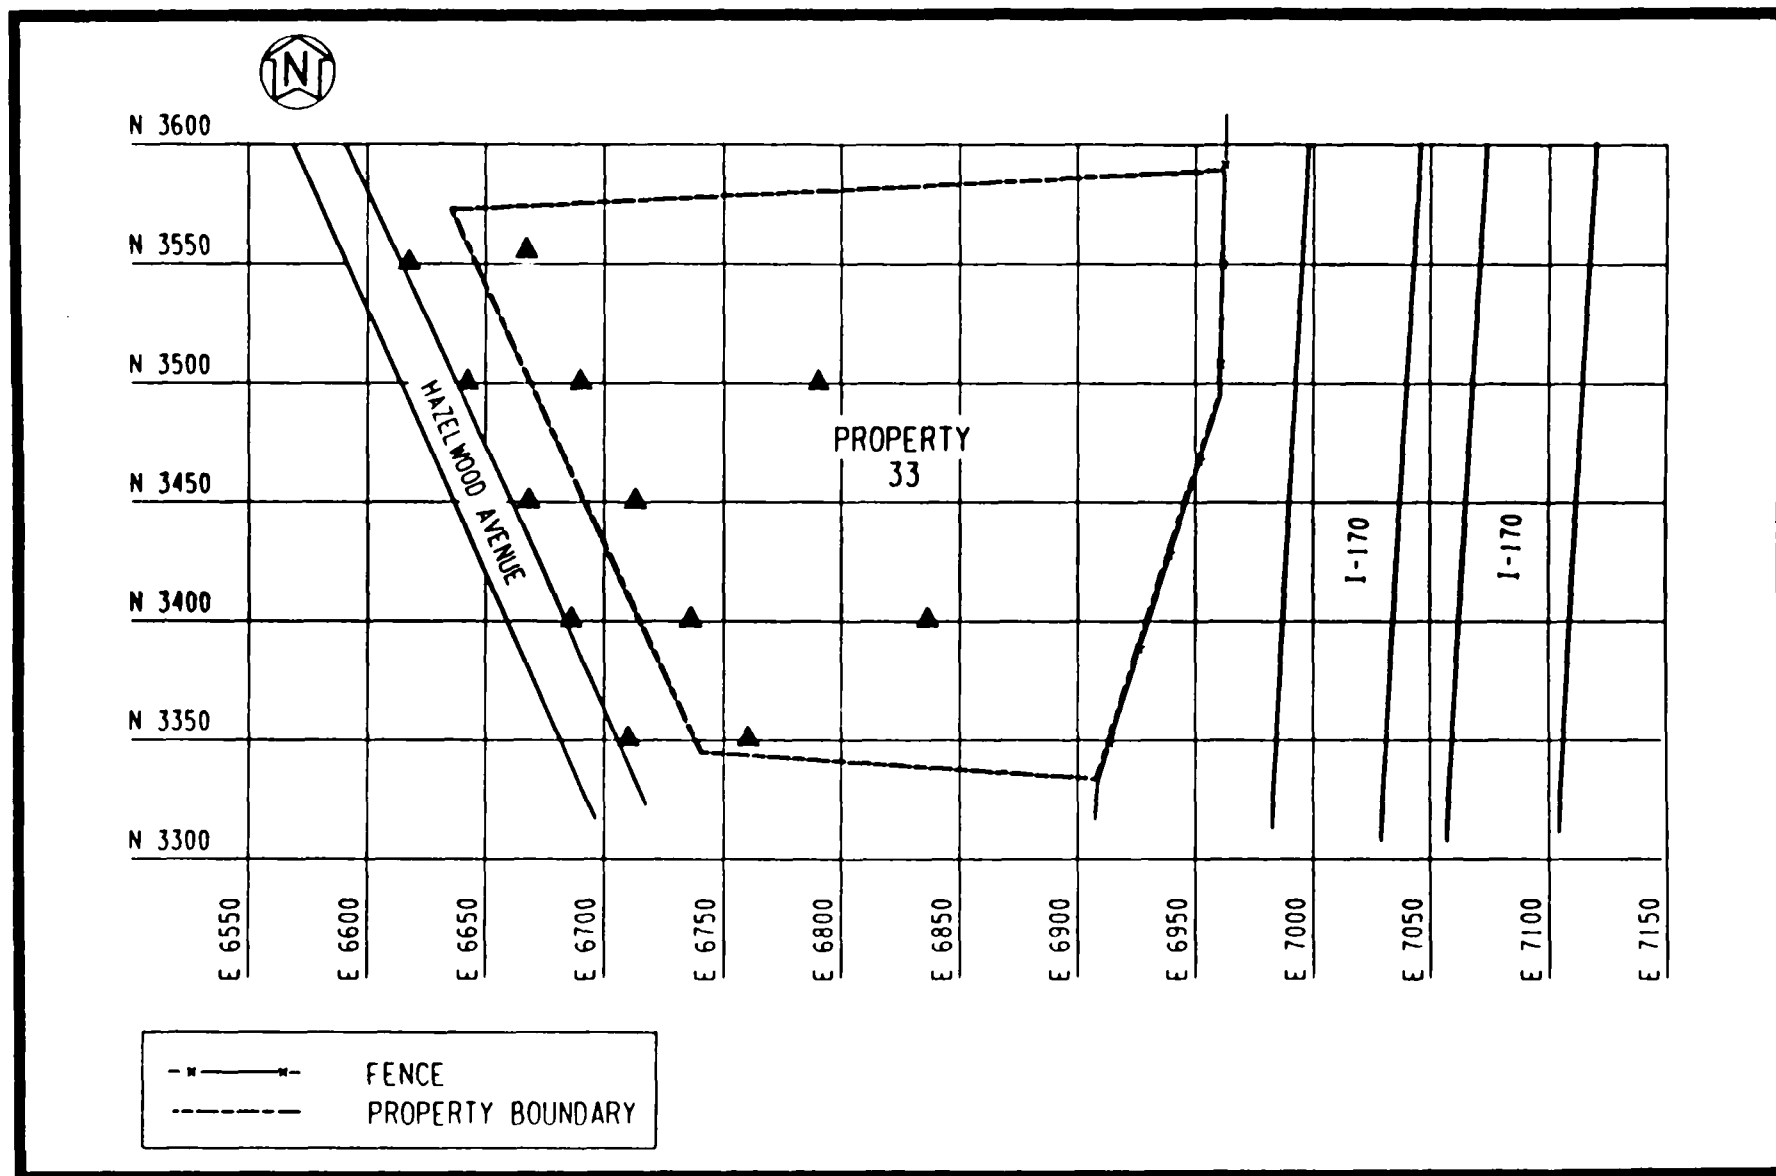
FIGURE 5-67 SOIL SAMPLING LOCATIONS FOR RADIOLOGICAL CHARACTERIZATION OF HAUL ROADS VICINITY PROPERTY 33

Property 33 is located on Hazelwood Avenue. Soil sampling locations are shown in Figure 5-67. Analytical results for soil (Table 5-42) revealed elevated concentrations of thorium-230 at four locations.

Thorium-230 concentrations ranged from 1.1 to 170 pCi/g. Areas and depths of radioactive contamination at Property 33 are shown in Figure 5-68.

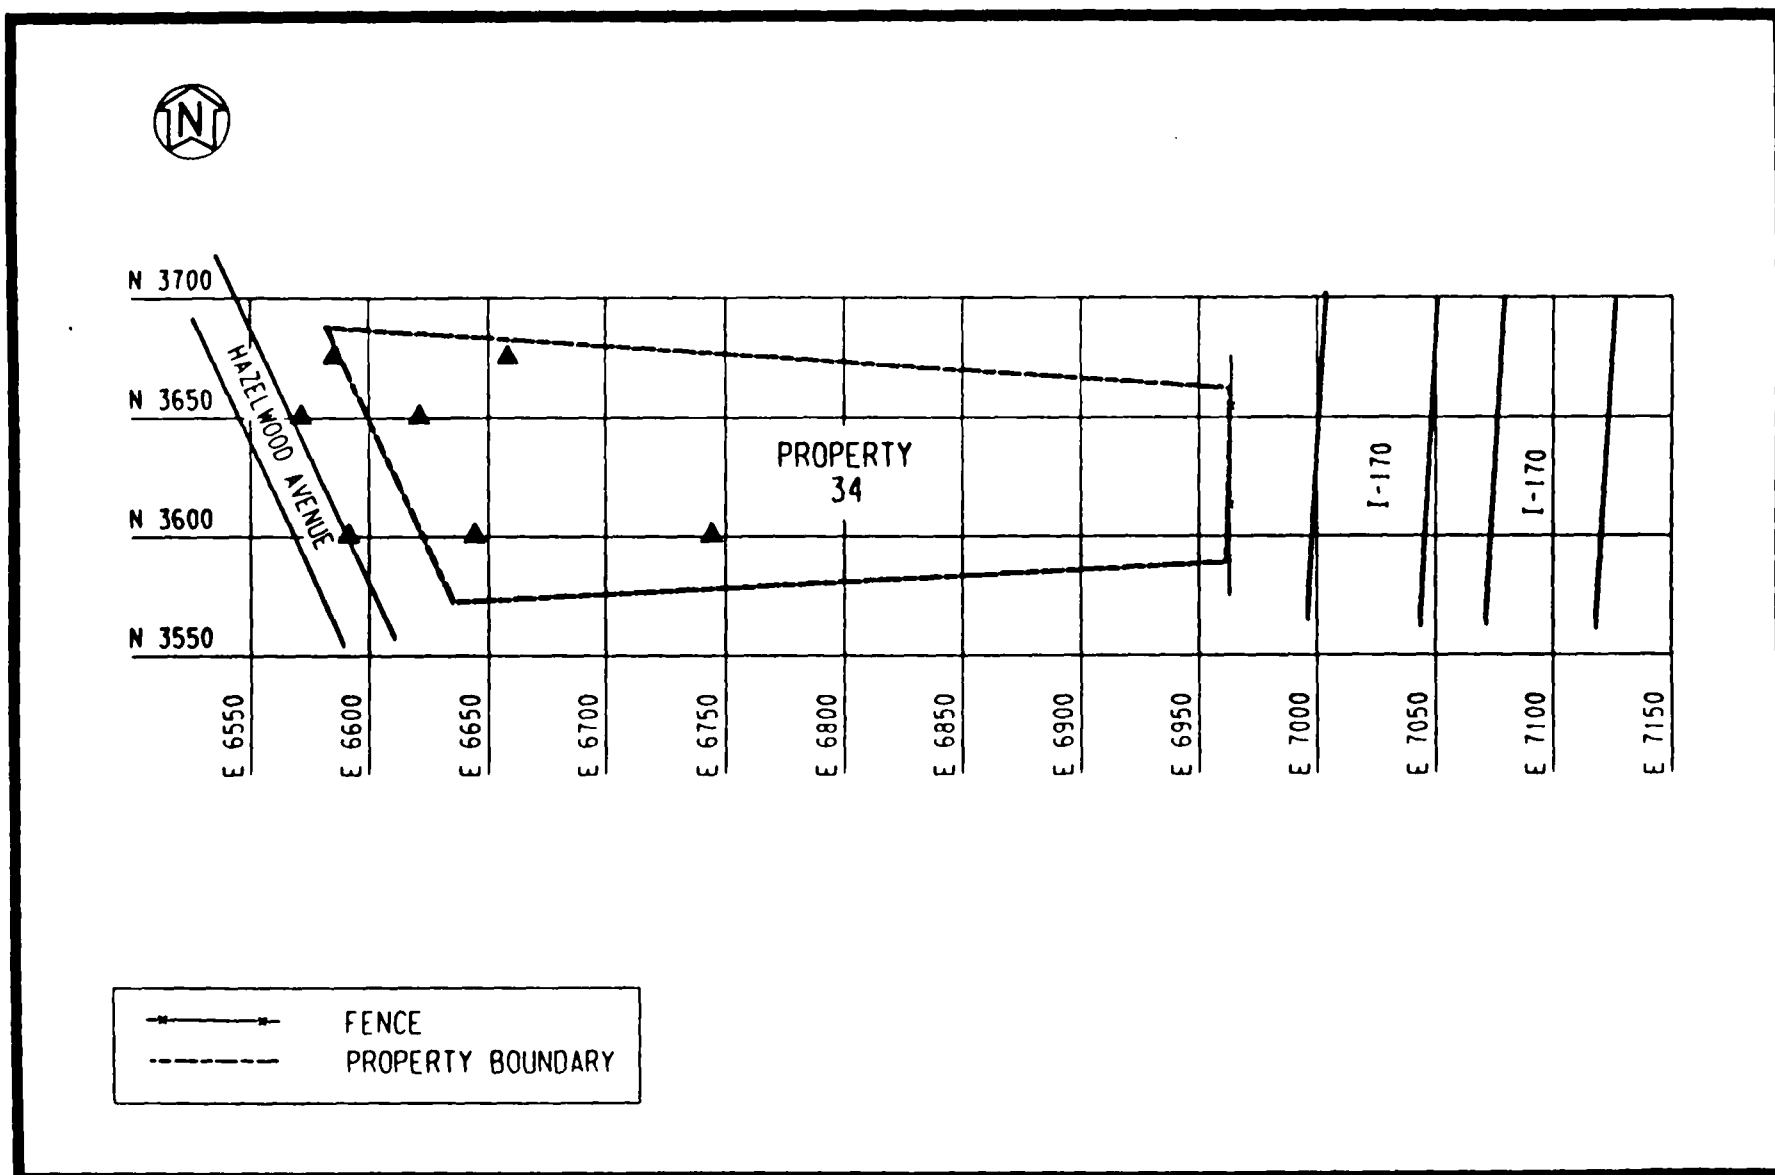
FIGURE 5-69 SOIL SAMPLING LOCATIONS FOR RADIOLOGICAL CHARACTERIZATION OF HAUL ROADS VICINITY PROPERTY 34

Property 34 is located on Hazelwood Avenue. Soil sampling locations are shown in Figure 5-69. Analytical results for soil collected from this property (Table 5-43) revealed three areas with elevated concentrations of thorium-230, which ranged from 1.3 to 140 pCi/g. Areas and depths of contamination at Property 34 are shown in Figure 5-70.

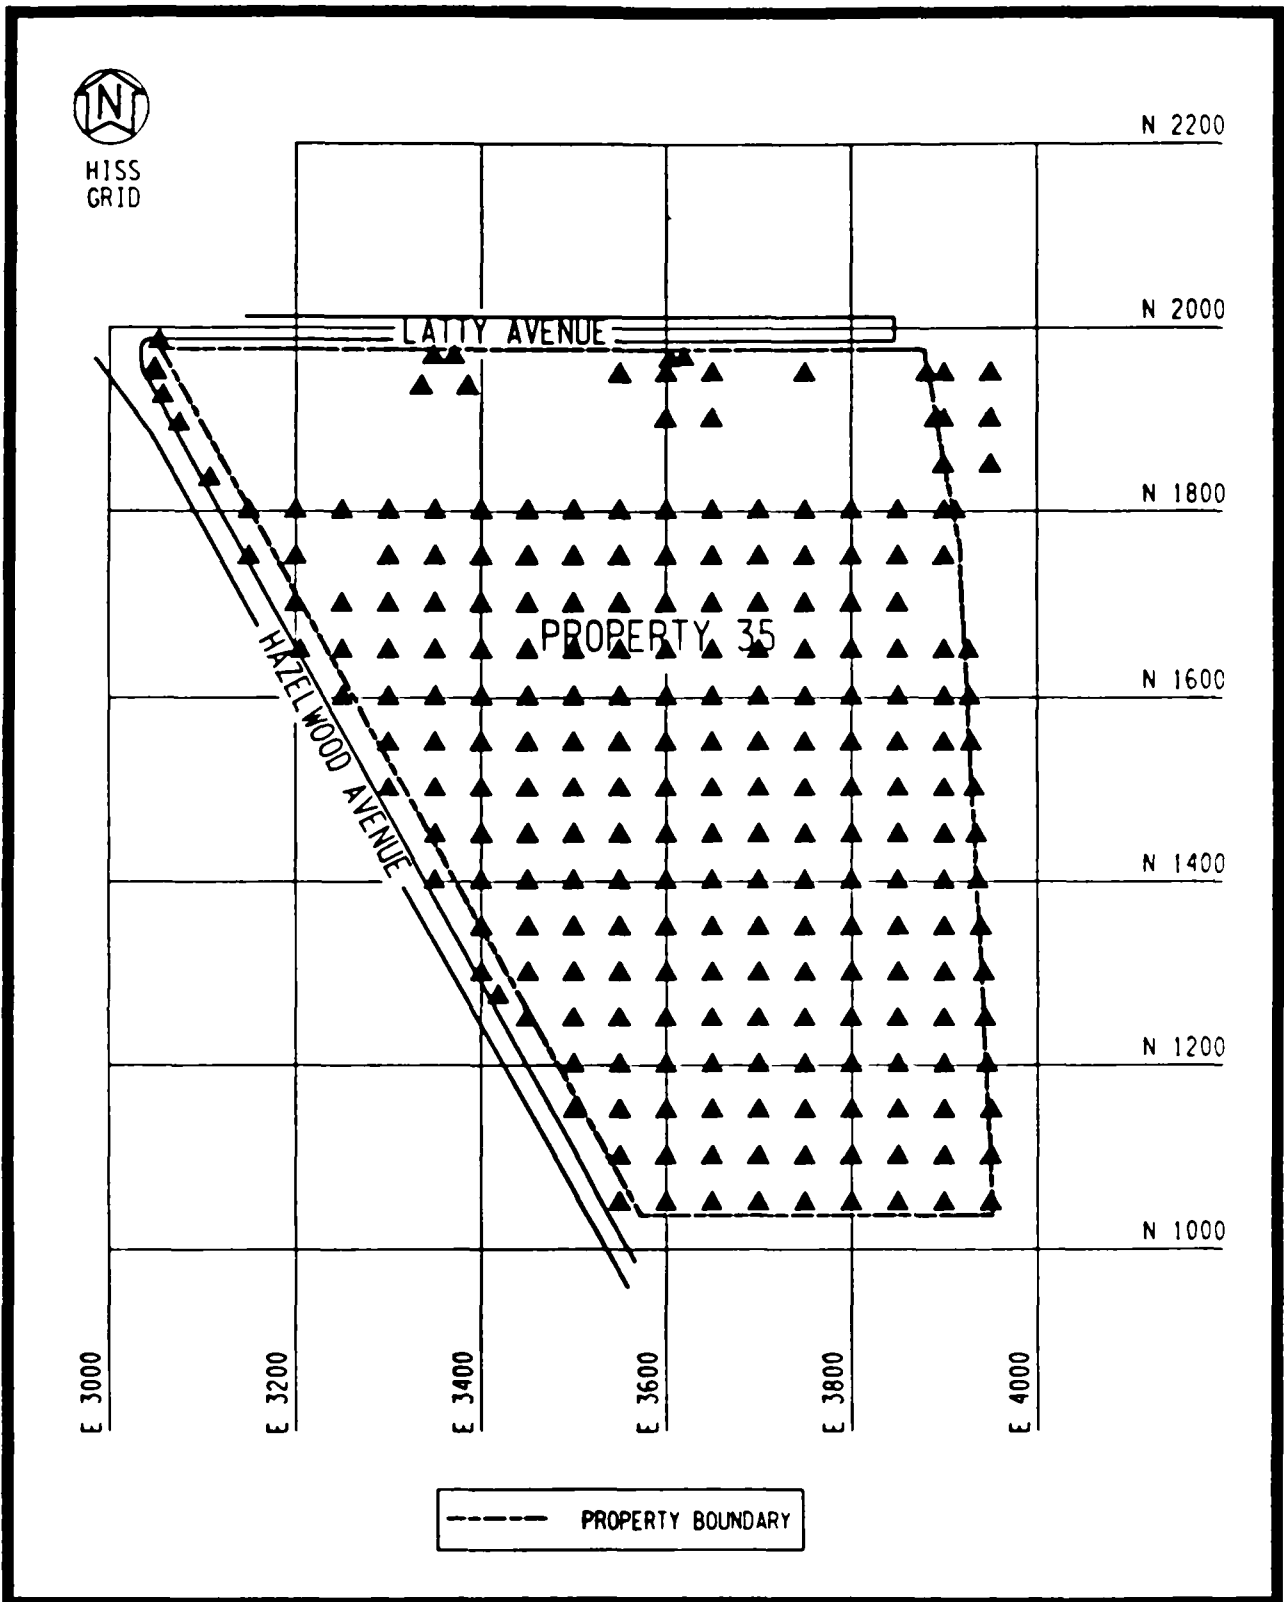
FIGURE 5-71 SURFACE SOIL SAMPLING LOCATIONS FOR 1988
 RADIOLOGICAL CHARACTERIZATION OF HAUL ROADS
 VICINITY PROPERTY 35

Surface soil sampling locations from the 1988 survey conducted on Property 35 are shown in Figure 5-71. Subsurface locations are shown in Figure 5-72. (Note that these samples were collected using the Latty Avenue grid system.) In an effort to better define the

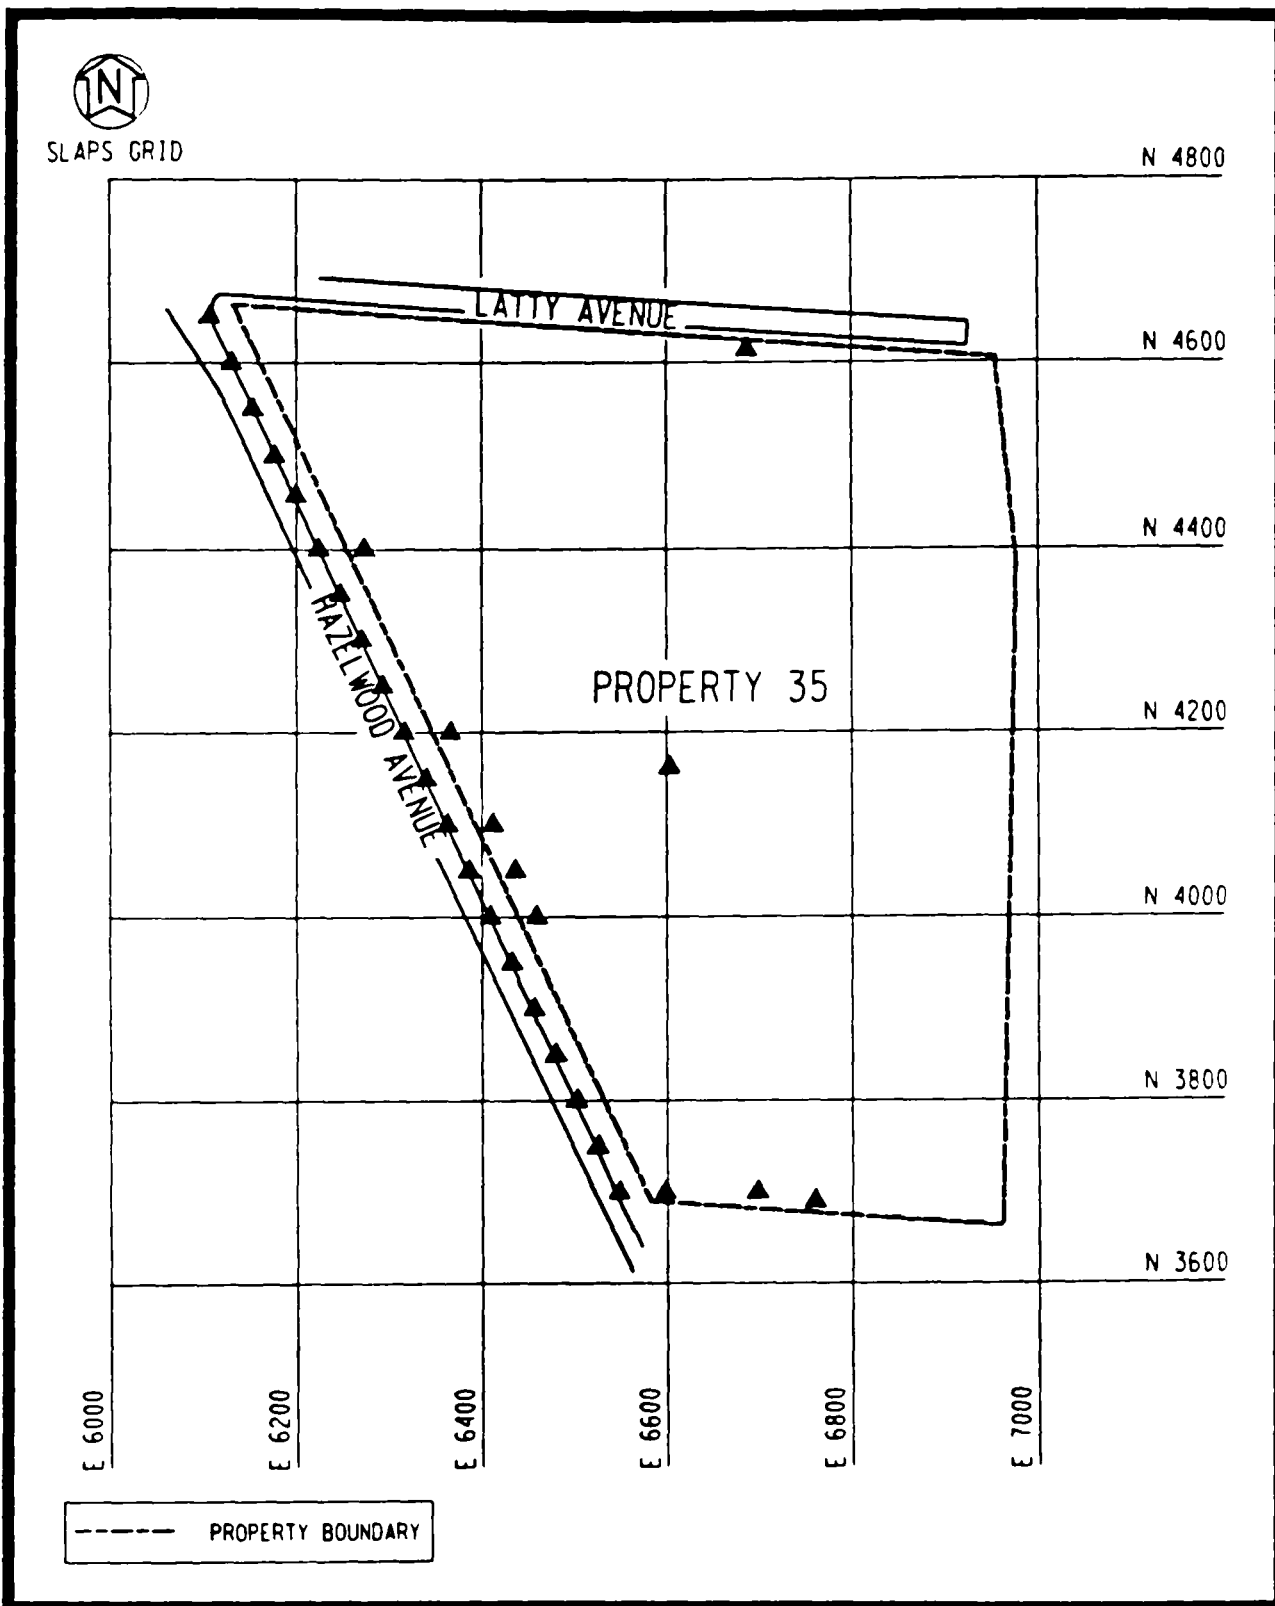
FIGURE 5-72 SUBSURFACE SOIL SAMPLING LOCATIONS FOR 1988
 RADIOLOGICAL CHARACTERIZATION OF HAUL ROADS
 VICINITY PROPERTY 35

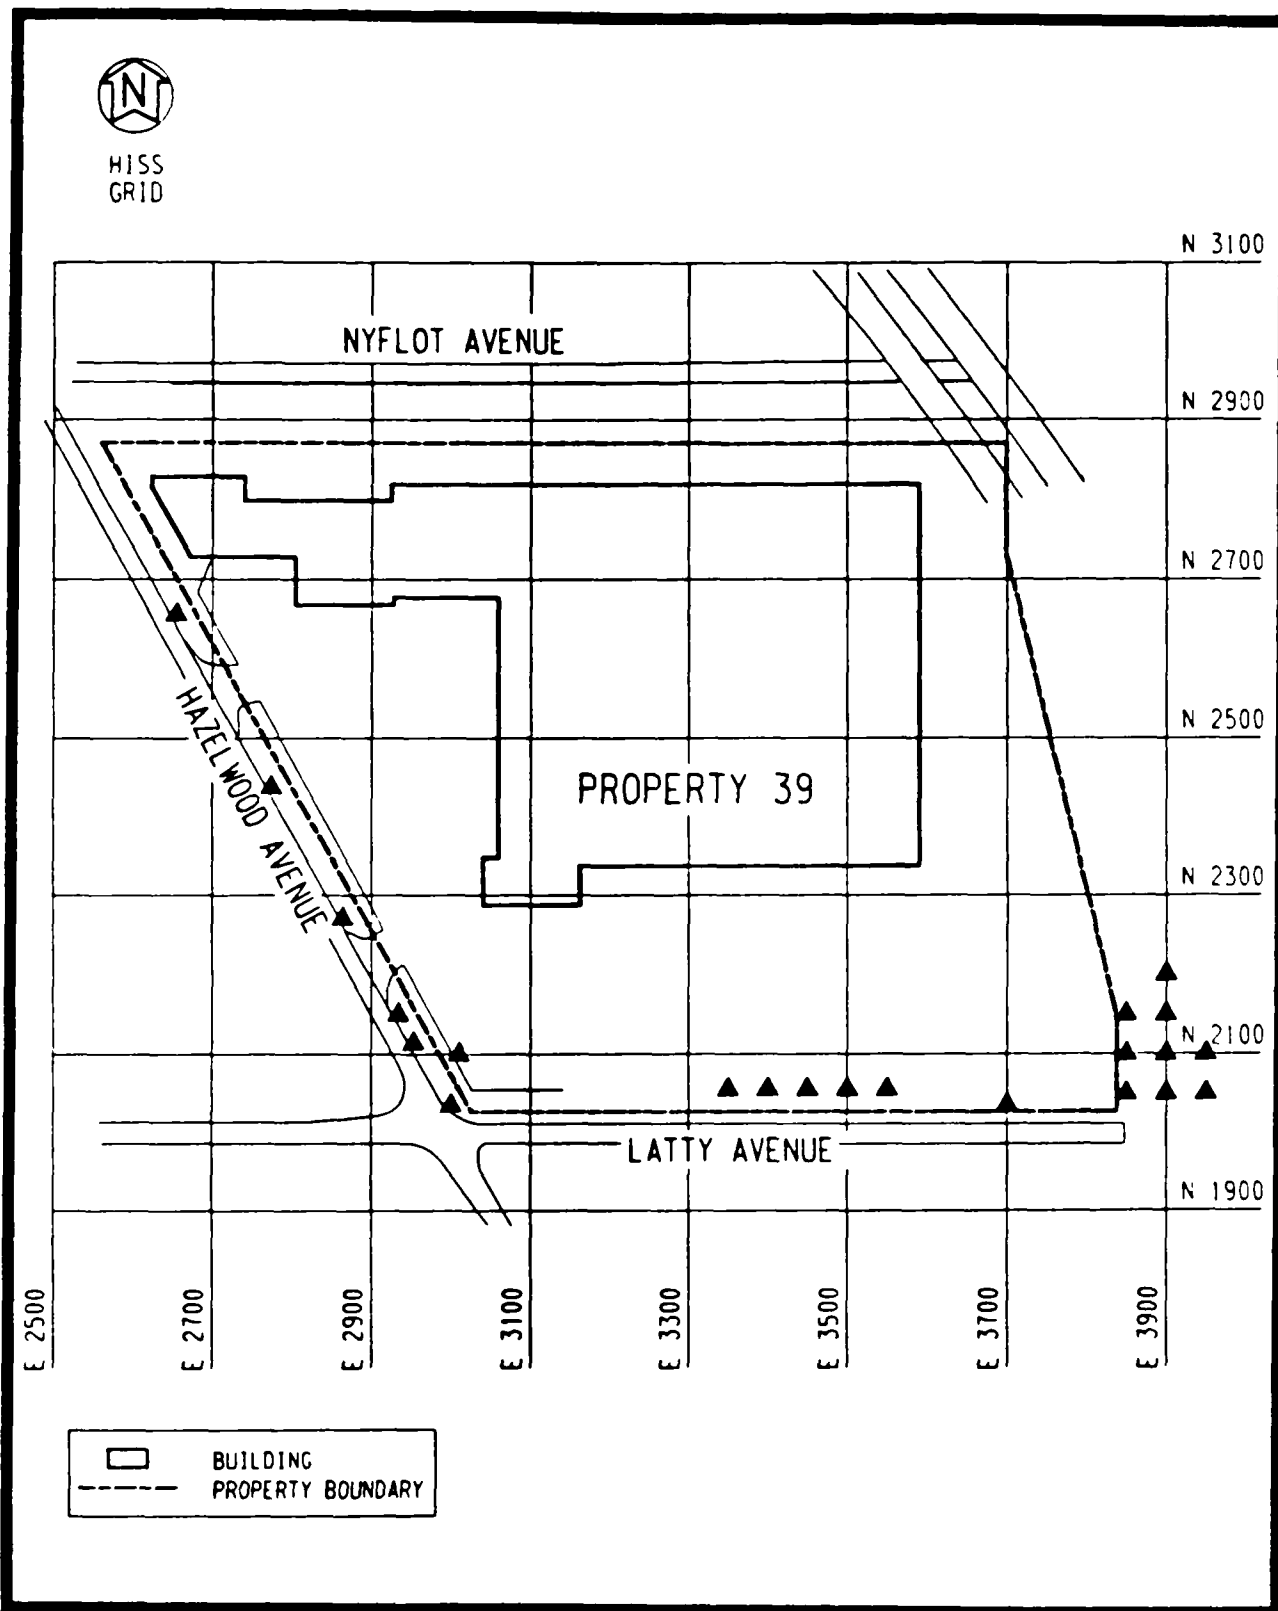
FIGURE 5-83 SURFACE SOIL SAMPLING LOCATIONS FOR 1987
RADIOLOGICAL CHARACTERIZATION OF HAUL ROADS
VICINITY PROPERTY 39

Surface soil sampling locations from the 1987 survey conducted on Property 39 are shown in Figure 5-83. Subsurface locations are shown in Figure 5-84. (Note that these samples were collected using the Latty Avenue grid system.) In an effort to better define the boundaries of radioactive contamination on this property, additional sampling was performed during the haul roads vicinity property surveys in 1989. Soil sampling locations on Property 39 from the 1989 radiological survey are shown in Figure 5-85. (Note that these samples were collected using the SLAPS grid system.)

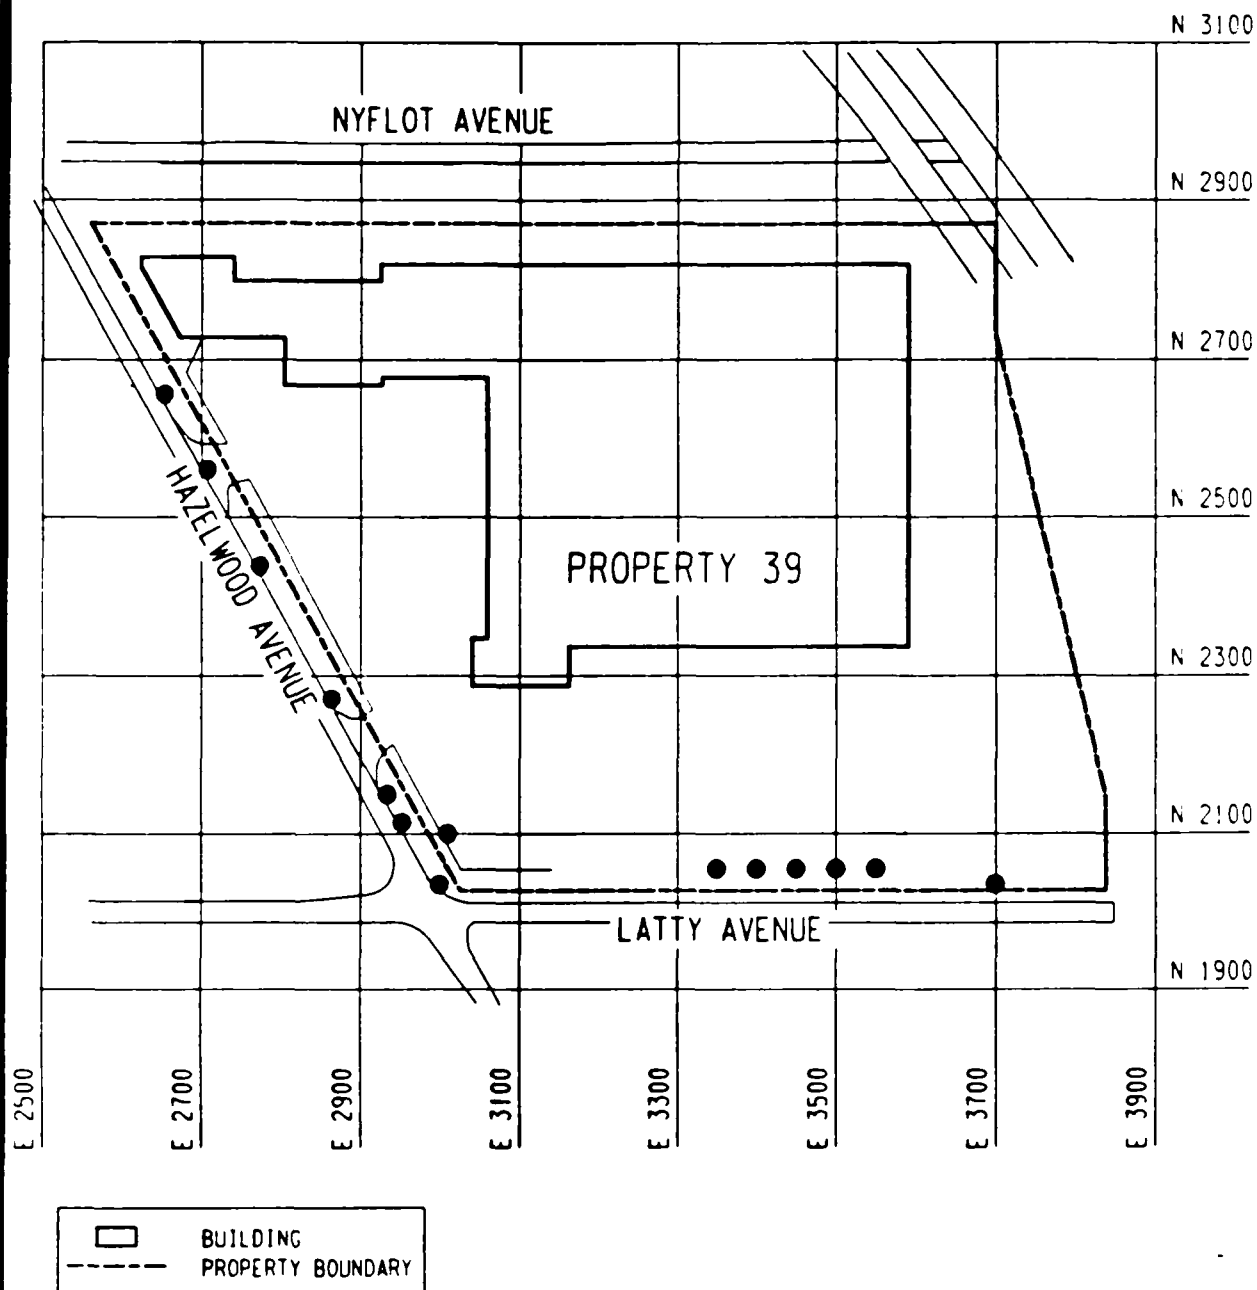
FIGURE 5-84 SUBSURFACE SOIL SAMPLING LOCATIONS FOR 1987
RADIOLOGICAL CHARACTERIZATION OF HAUL ROADS
VICINITY PROPERTY 39

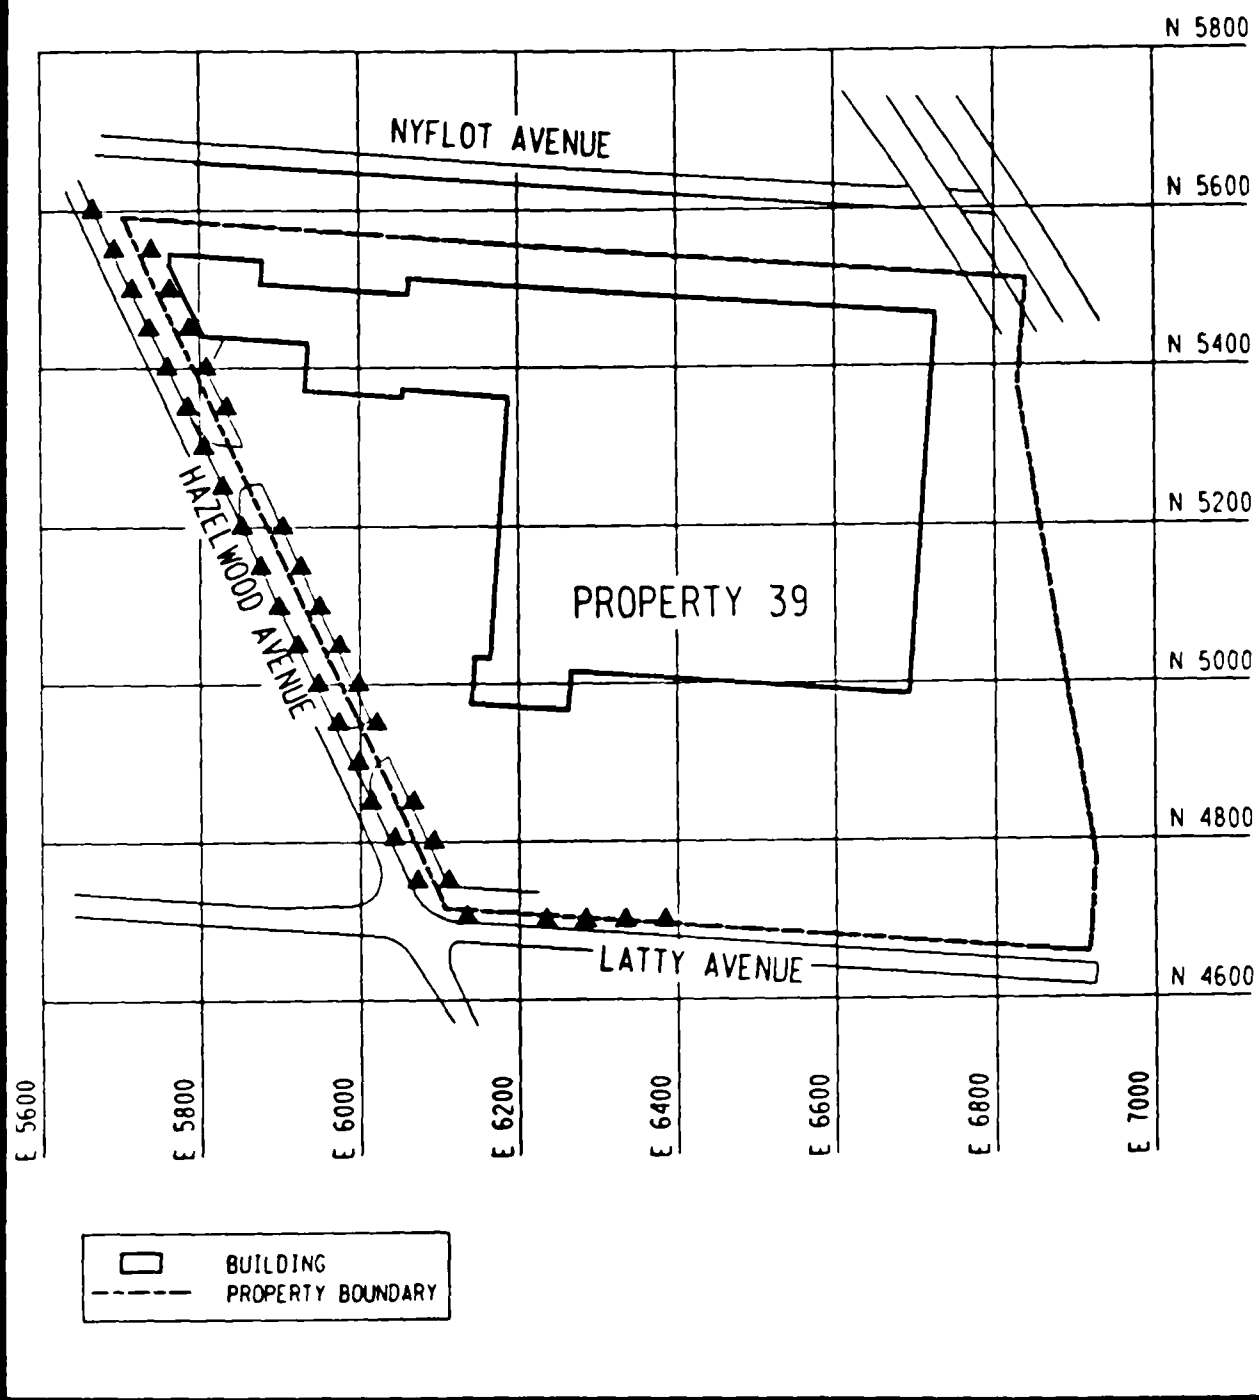
FIGURE 5-85 SOIL SAMPLING LOCATIONS FOR 1989 RADIOLOGICAL CHARACTERIZATION OF HAUL ROADS VICINITY PROPERTY 39

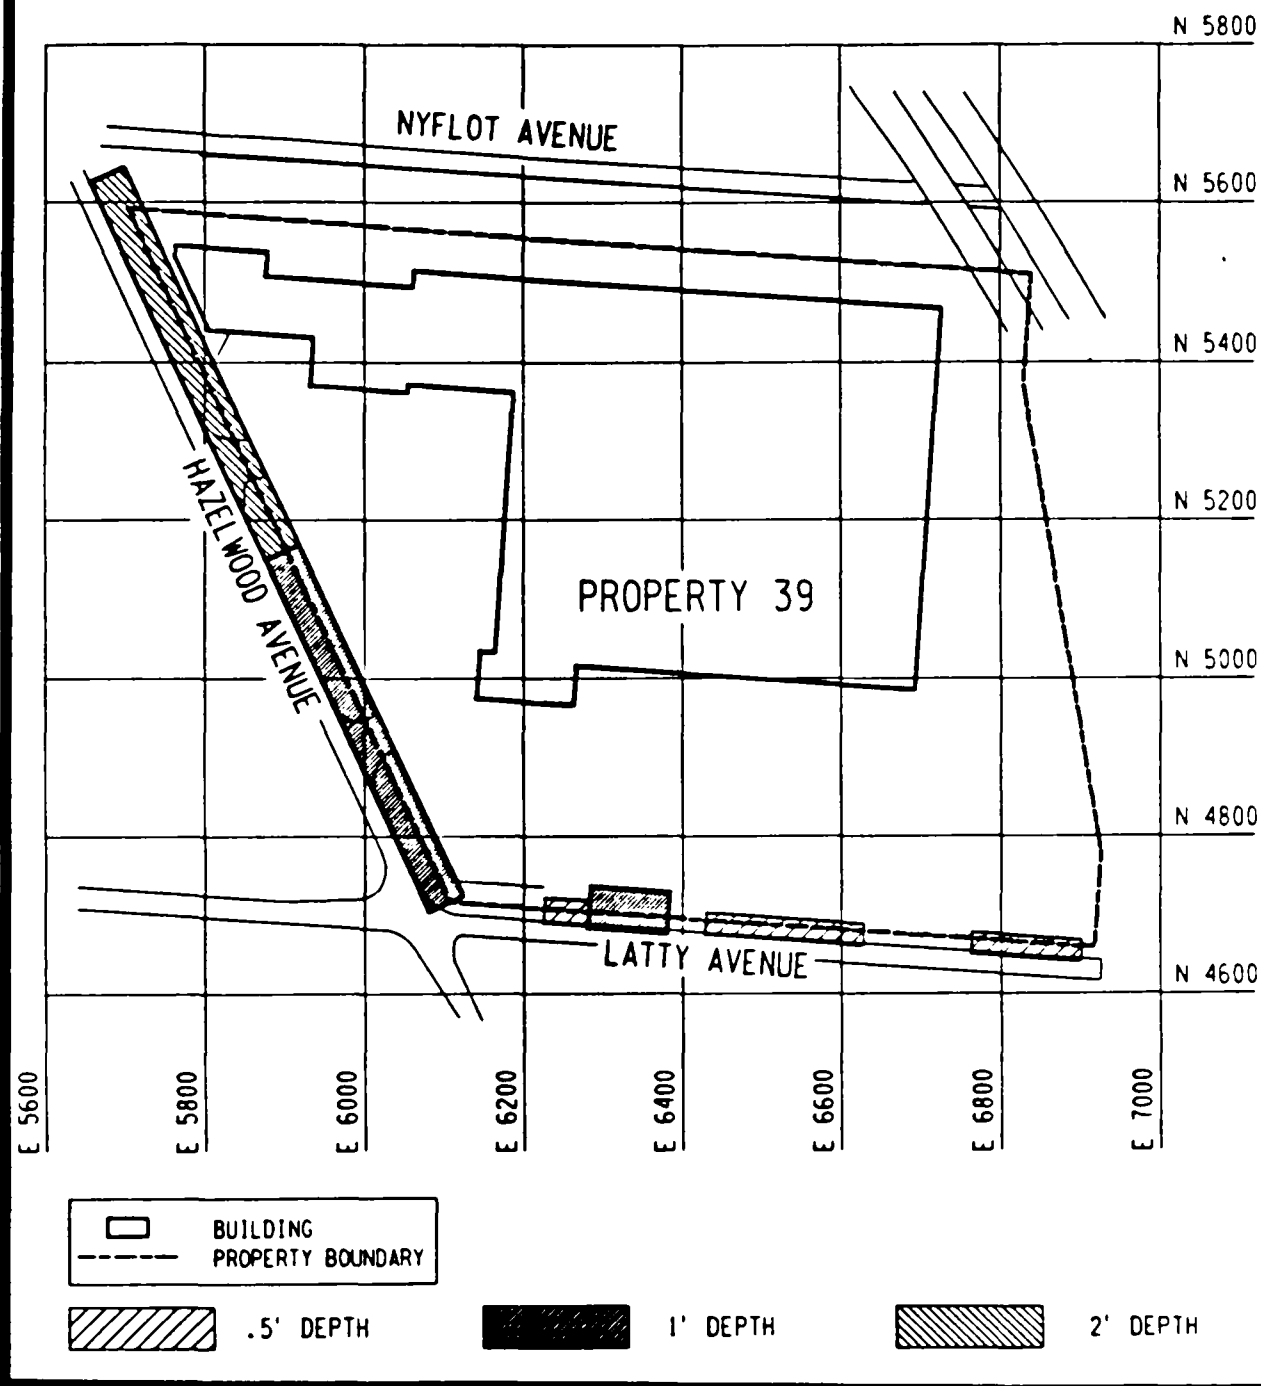
FIGURE 5-86 AREAS AND DEPTHS OF RADIOACTIVE CONTAMINATION AT HAUL ROADS VICINITY PROPERTY 39

Analytical results for soil revealed areas exhibiting elevated concentrations of thorium-230 in surface and subsurface soils. All uranium-238 concentrations were less than 14 pCi/g. Radium-226 concentrations ranged from 0.7 to 3.2 pCi/g. Concentrations of thorium-232 and thorium-230 ranged from 0.6 to 3 pCi/g and from less than 0.8 to 200 pCi/g, respectively. Analytical results for soil collected and analyzed from the 1987 survey are provided in Table 5-54. Soil samples collected during the 1989 characterization effort at the haul roads are reported in Table 5-55. The boundaries of radioactive contamination at Property 39 are shown in Figure 5-86.

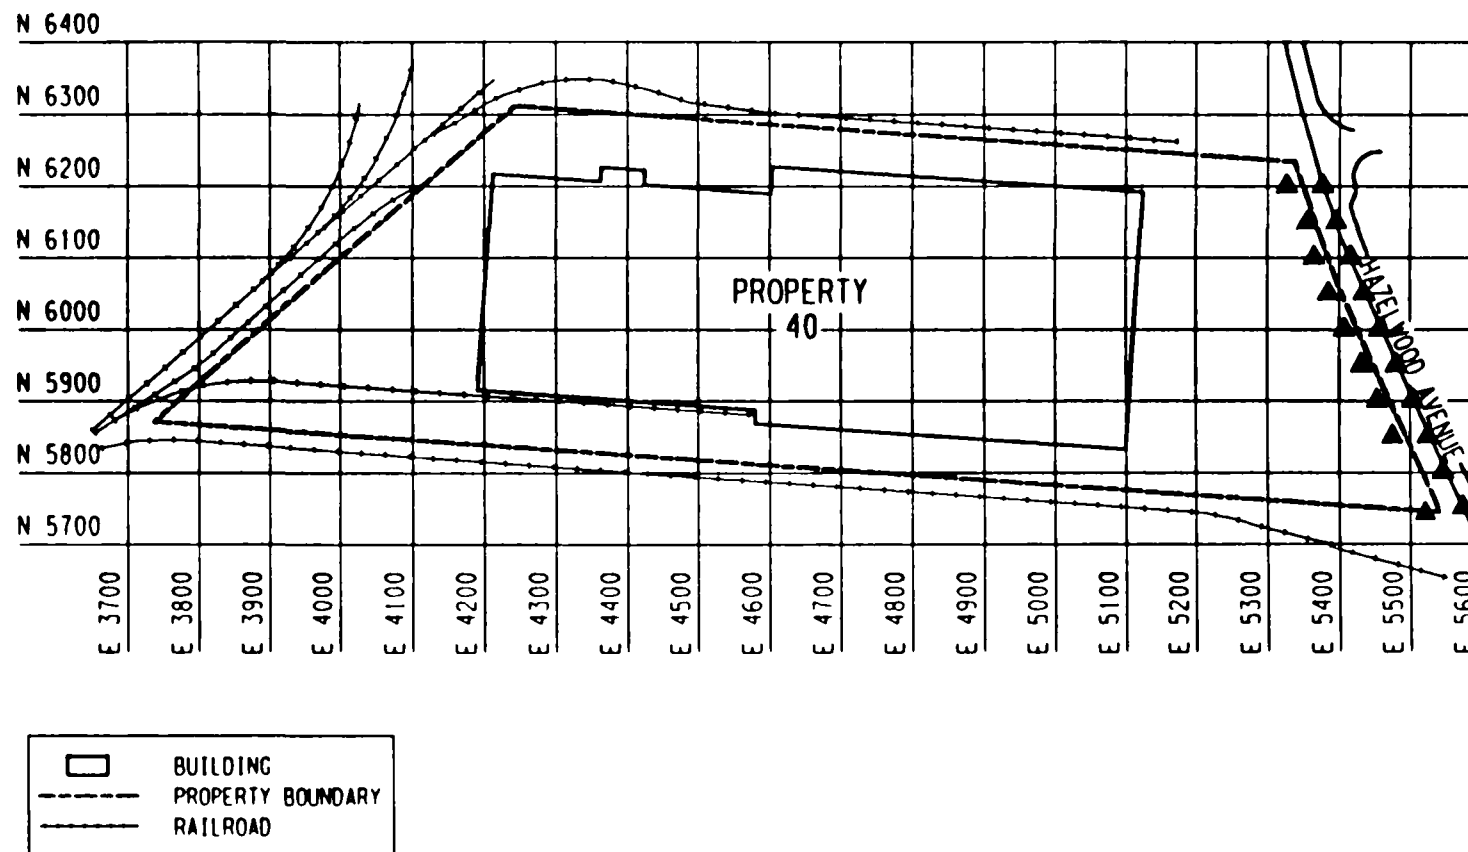
FIGURE 5-87 SOIL SAMPLING LOCATIONS FOR RADIOLOGICAL CHARACTERIZATION OF HAUL ROADS VICINITY PROPERTY 40

Property 40 is located on Hazelwood Avenue. Soil sampling locations from which samples were collected and analyzed from Property 40 are shown in Figure 5-87. Analytical results for soil (Table 5-56) revealed nine sampling locations with elevated levels of thorium-230. Thorium-230 concentrations ranged from less than 0.5 to 110 pCi/g. Areas and depths of radioactive contamination at Property 40 are shown in Figure 5-88.

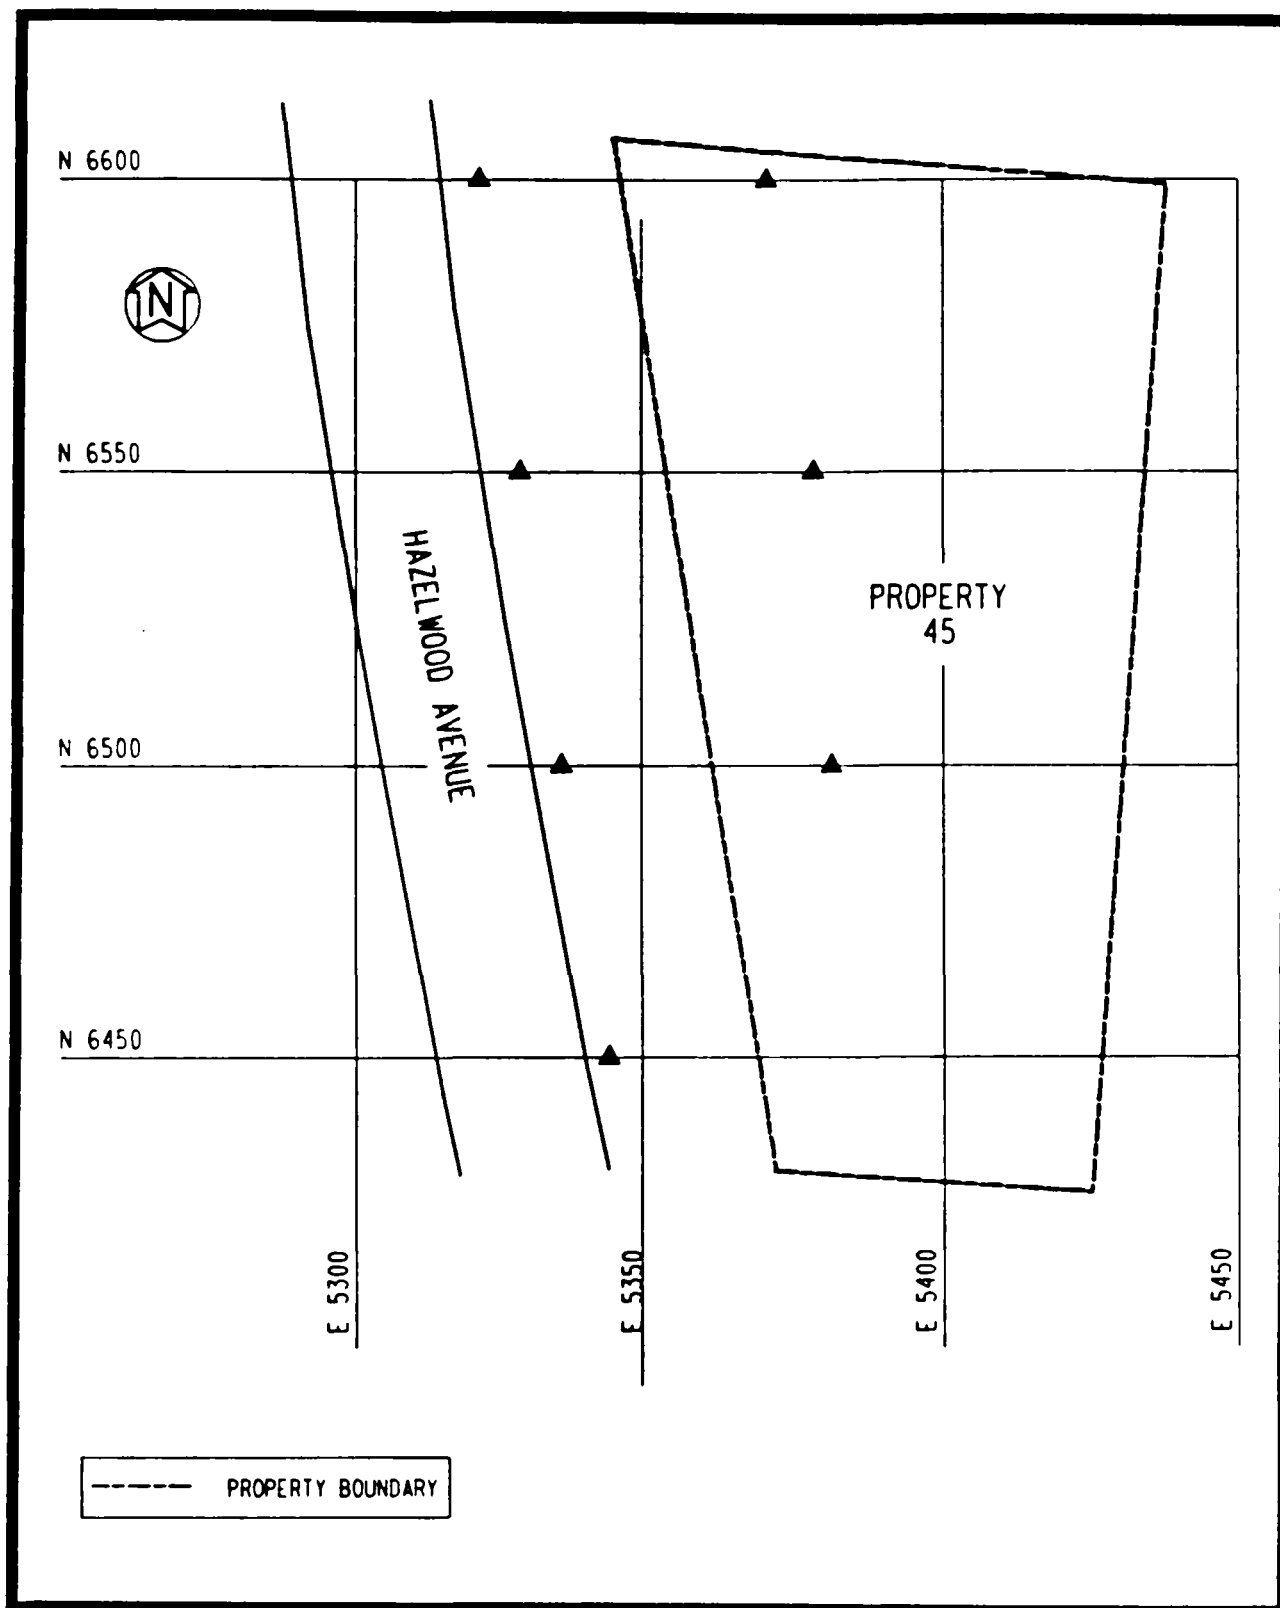
FIGURE 5-97 SOIL SAMPLING LOCATIONS FOR RADIOLOGICAL CHARACTERIZATION OF HAUL ROADS VICINITY PROPERTY 45

Property 45 is located on Hazelwood Avenue. Locations from which soil samples were collected and analyzed are shown in Figure 5-97. Analytical results for soil (Table 5-61) revealed three sampling locations exhibiting elevated levels of thorium-230, which ranged from 1 to 21 pCi/g. Areas and depths of radioactive contamination at Property 45 are shown in Figure 5-98.
